Pre-Purchase Inspection - Residential Building Report

Complies with Australian Standard AS 4349.1- 2007 Inspection of Buildings Part 1: Pre-Purchase inspections - Residential buildings

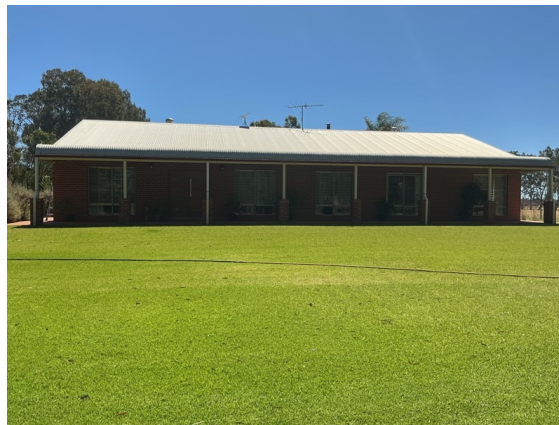
PURPOSE OF INSPECTION

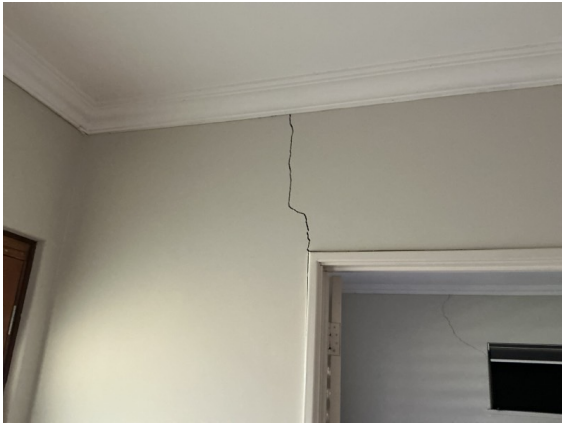
Entry - Evidence of cracking noted to various interior areas. Recommend repairs or seek further advice from a Structural Engineer.

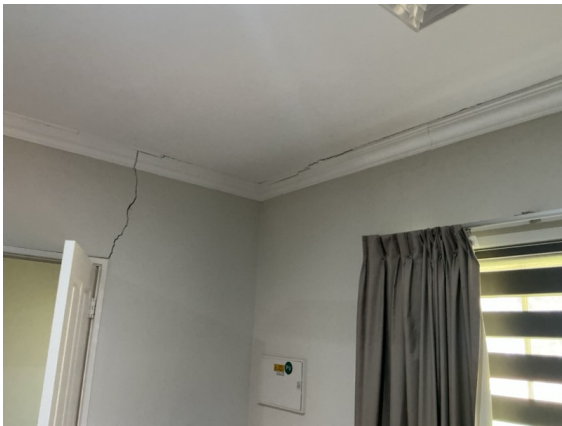
Bedroom 1/ entry wall - Vertical cracking

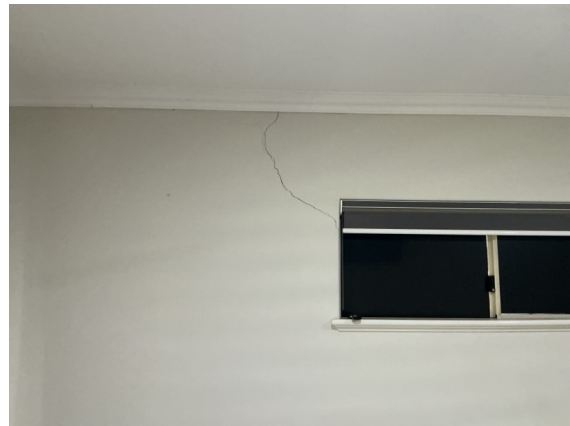
Bedroom 1 - Cracking adjacent to south elevation exterior noted in defect 2.

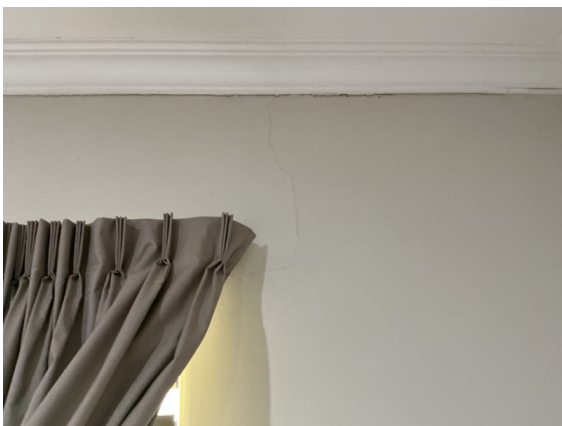
Bedroom 1 - Cracking adjacent to east elevation exterior noted in defect 2.

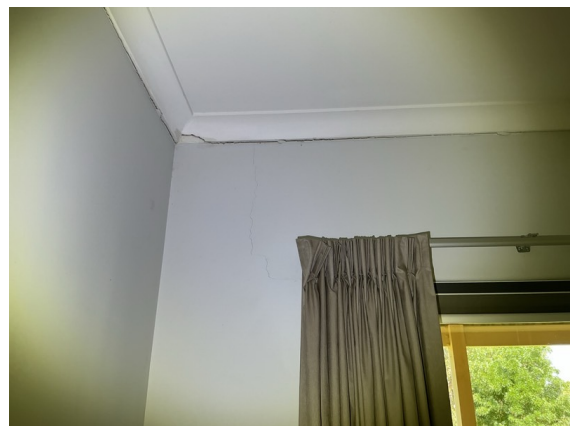
Bedroom 2 - Cracking adjacent to east elevation exterior noted in defect 2.

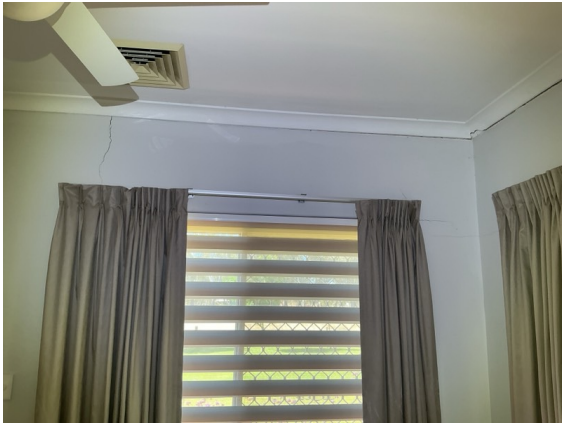
Bedroom 3 - Cracking adjacent to Northeast elevation exterior cracking noted in defect 2.

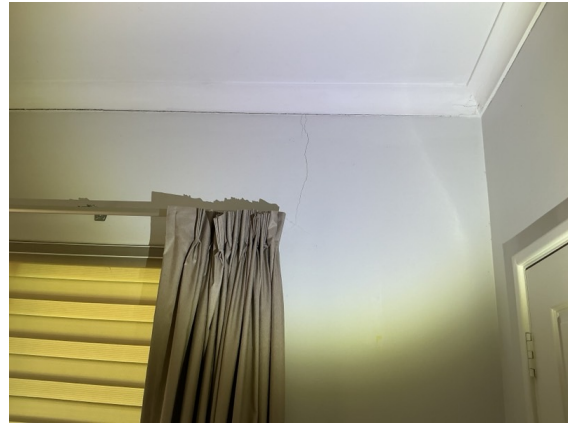
Bedroom 3 - Cracking adjacent to Northeast elevation exterior cracking noted in defect 2.

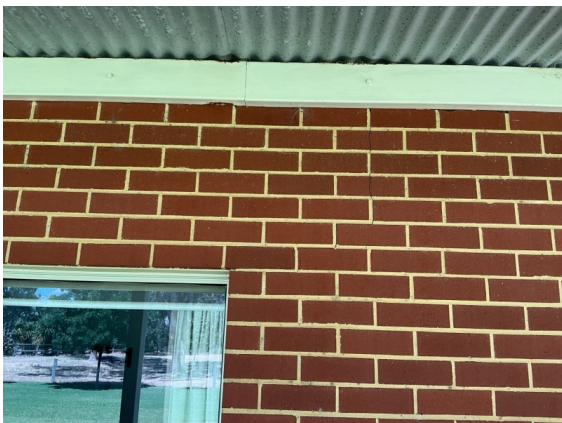
East elevation - Evidence of vertical and step cracking noted to various exterior walls. Recommend repairs or seek further advice from a Structural Engineer.

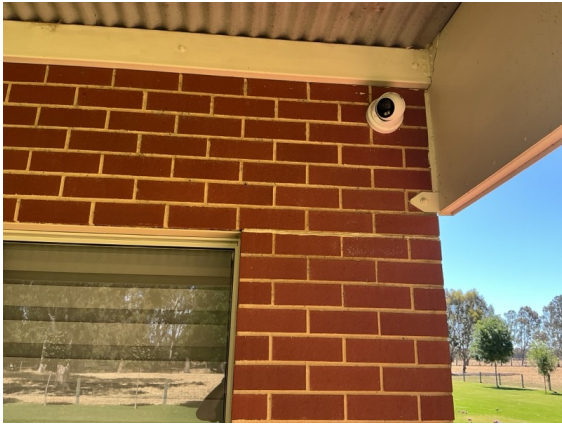
Northeast corner - Evidence of previous crack repairs. Recommend review by qualified tradesman and repairs as required.

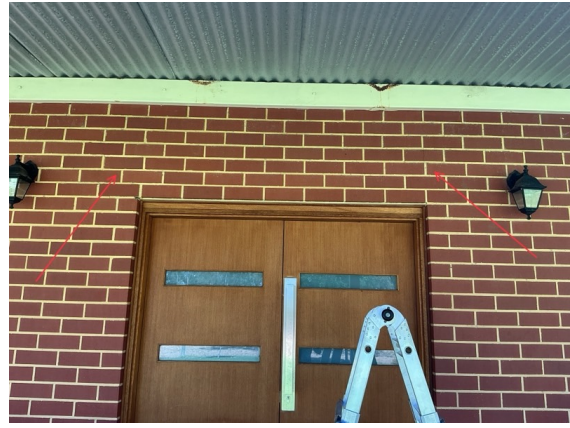
Entry - Evidence of vertical and step cracking noted above the entry door.

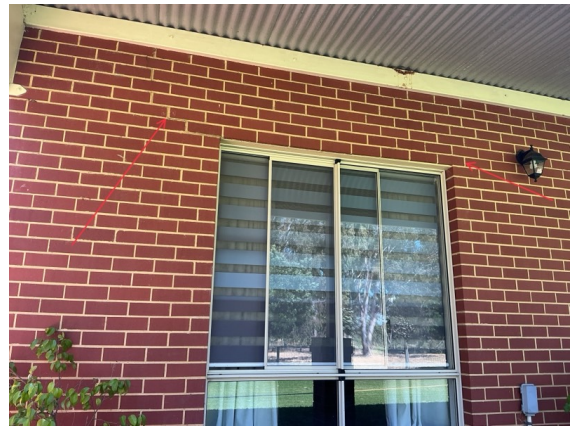
Southeast corner - Evidence of step and vertical cracking which has been previous repaired. Recommend review by qualified tradesman and repairs as required.

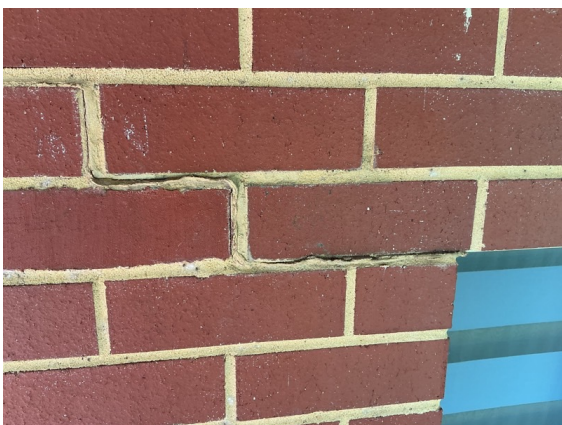
Previous crack repairs.

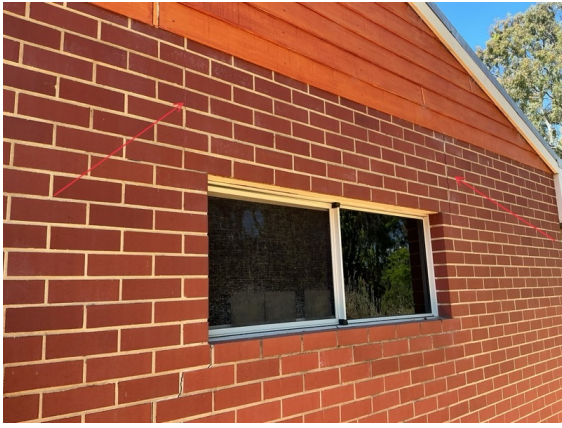
South elevation - Evidence of vertical and step cracking noted above and below the bedroom 1 window.

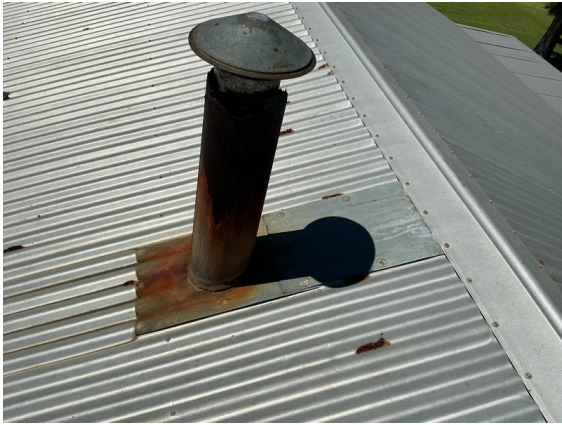
Deterioration to the roof flume on the west elevation. Recommend replacement.

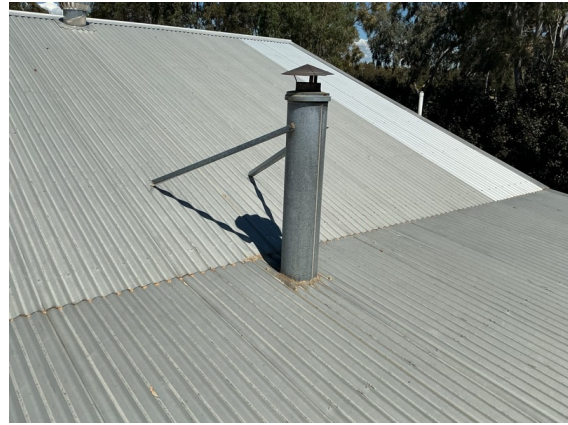
There is no dektite installed to the alfresco fire place flume. Recommend installing a fire rated dektite and silicone.

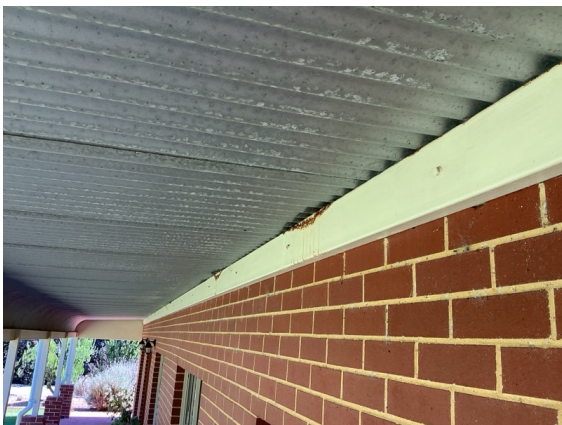
Surface rust noted to the exterior roof sheets and steel framed roof members at the crack line between the house and verandah on the east elevations. Recommend maintenance/repairs.

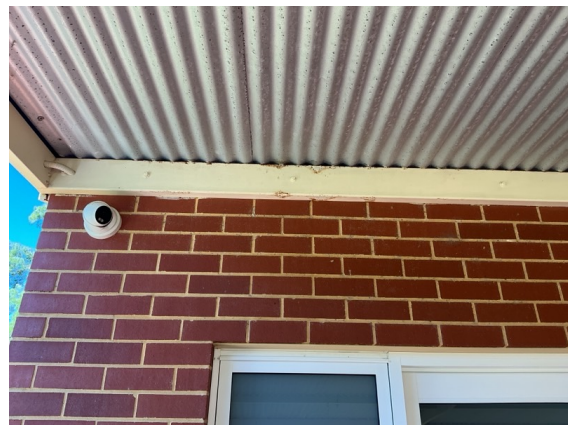
Surface rust noted to the exterior roof sheets and steel framed roof members at the crack line between the house and alfresco on the west elevation. Recommend maintenance/repairs.

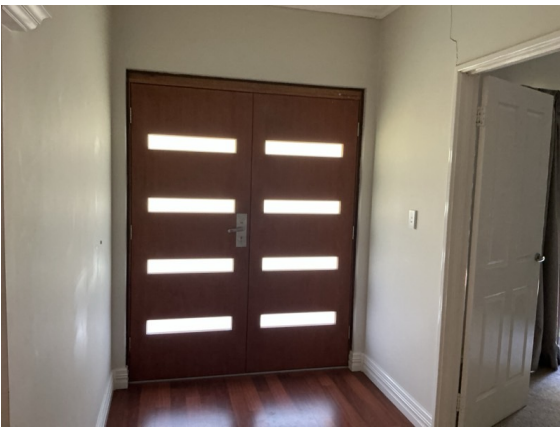
The inspector is not required to comment on individual minor defects and imperfections. If noted, it is expected that defects of this type would be rectified as part of normal ongoing property maintenance.

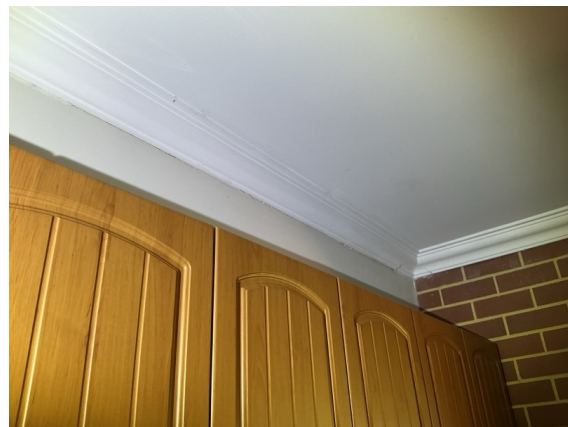
Typical appearance cracking noted to the cornice at some isolated areas throughout the home. Recommend maintenance/repairs.

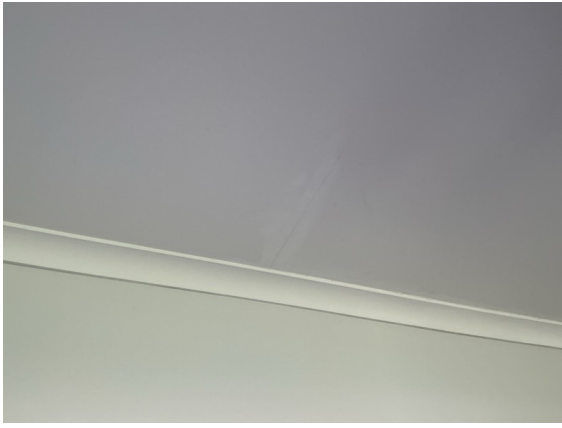
Typical appearance cracking noted to the ceiling junctions at some isolated areas throughout the home. Recommend maintenance/repairs.

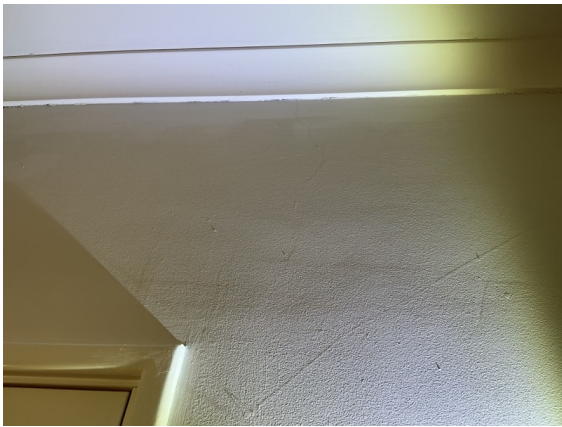
Typical appearance cracking noted to rendered walls at some isolated areas throughout the home. Recommend maintenance/repairs.

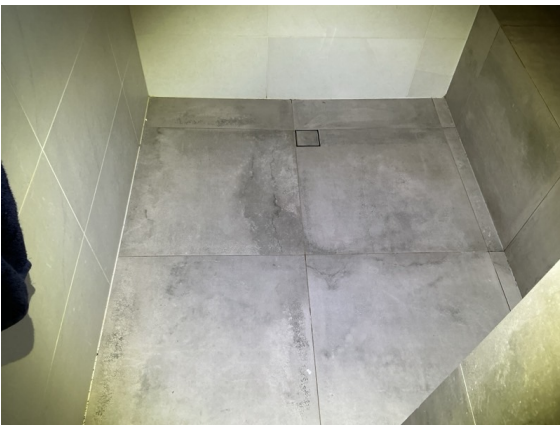
Ensuite shower recess - Although the walls adjacent to the shower recess tested in normal moisture range, minor deterioration was observed to the shower silicone and grout. Recommend to monitoring and maintenance/repairs as required.

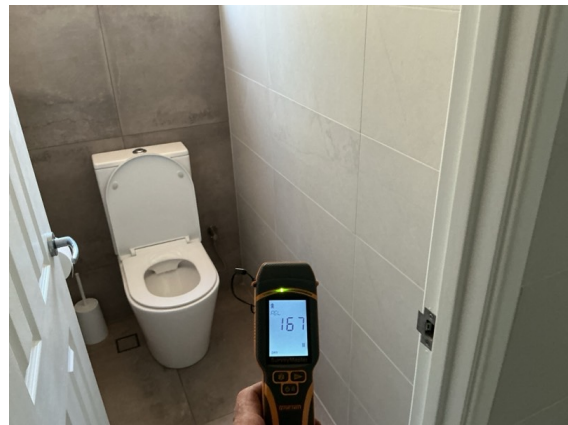
Toilet wall adjacent to the ensuite shower was checked for moisture and found to be within a normal range

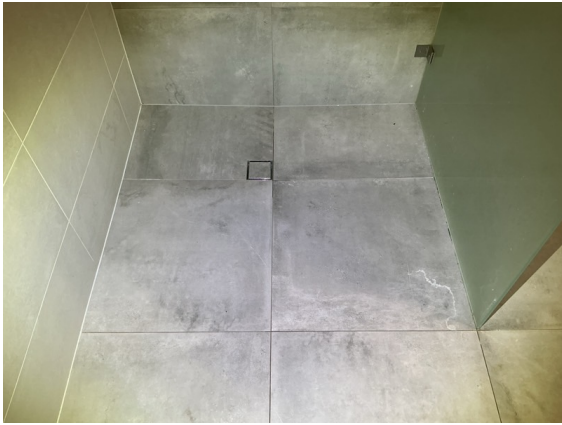
Bathroom shower recess

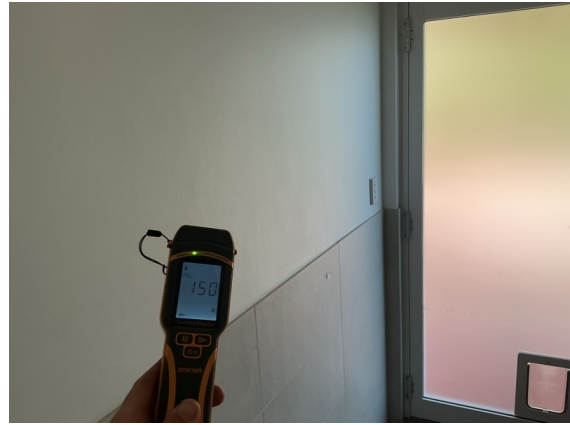
Laundry wall adjacent to the bathroom shower was checked for moisture and found to be within a normal range.

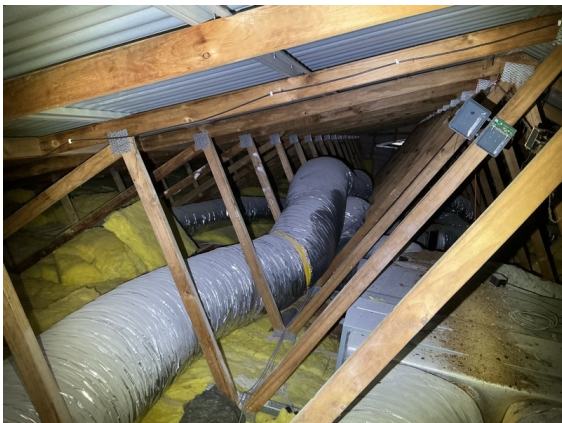
The inspector is not required to comment on individual minor defects and imperfections. If noted, it is expected that defects of this type would be rectified as part of normal ongoing property maintenance.

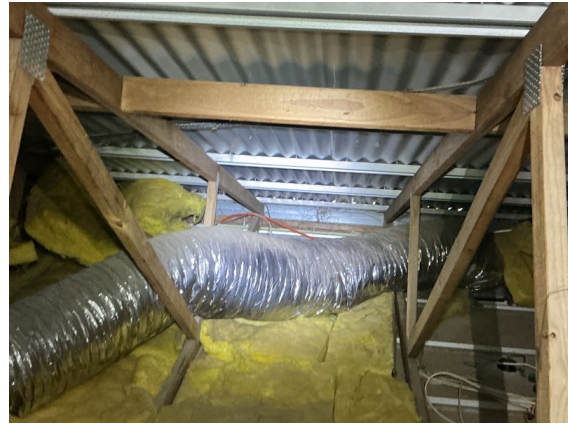
Premier tie down straps observed.

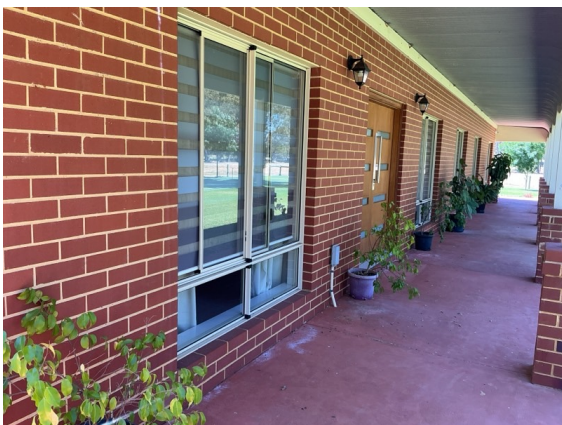
The inspector is not required to comment on individual minor defects and imperfections. If noted, it is expected that defects of this type would be rectified as part of normal ongoing property maintenance.

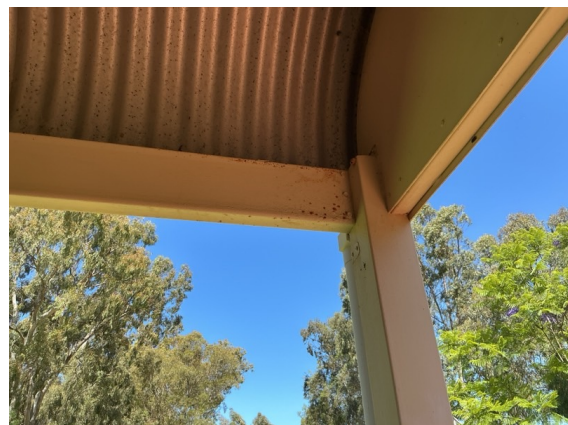
Surface rust noted to various steel posts and beams on the east and west elevations. Recommend maintenance/ repairs.

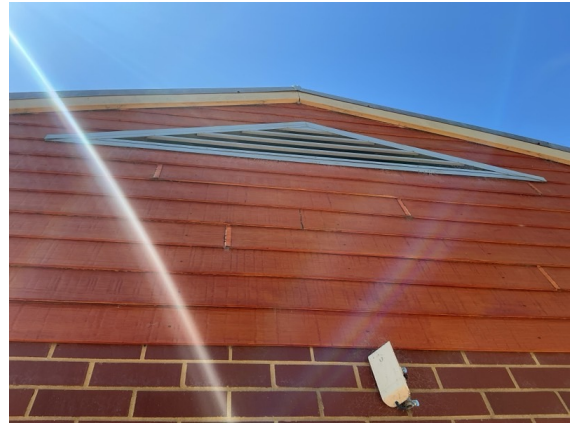
Deterioration noted to the north and south elevation gable weatherboards. Recommend maintenance/ repairs.

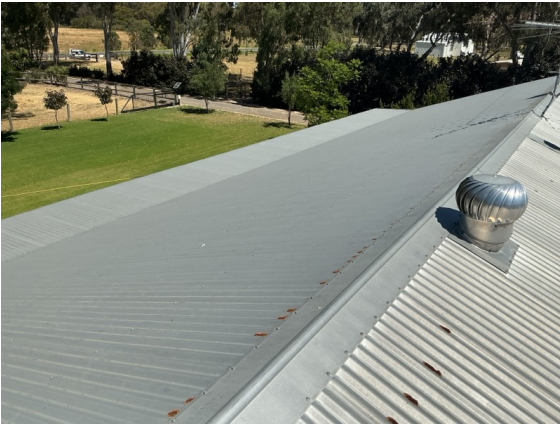
East elevation roof exterior

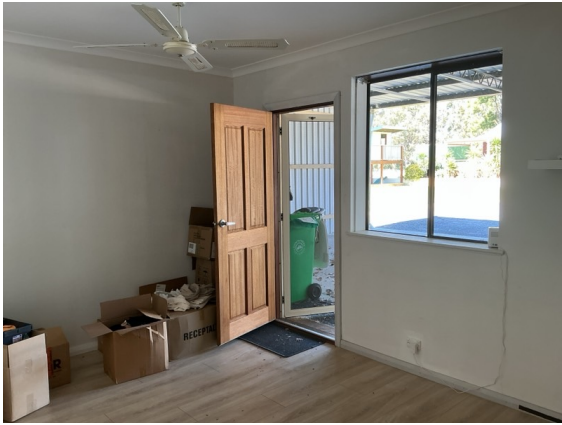
Entry - Recommend council record search for all shed additions and living areas.

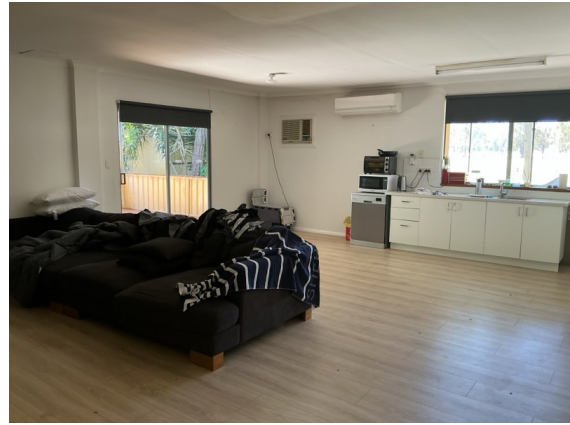
Living room/ kitchen

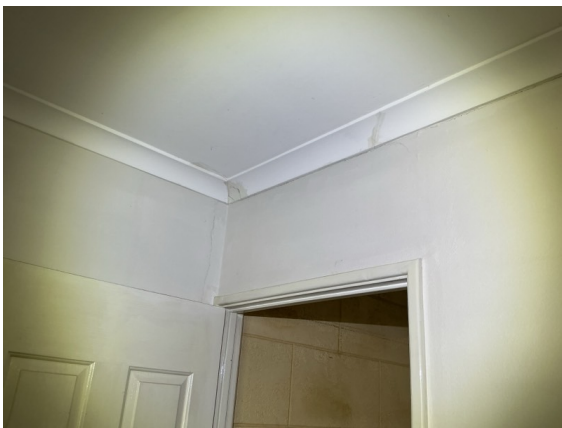
Typical appearance cracking noted to the cornice and rendered walls at some isolated areas throughout the shed. Recommend maintenance/repairs.

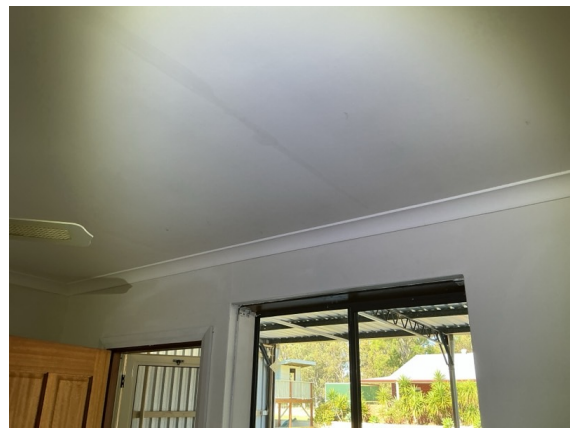
Typical appearance cracking noted to the ceiling junctions at some isolated areas throughout the shed. Recommend maintenance/repairs.

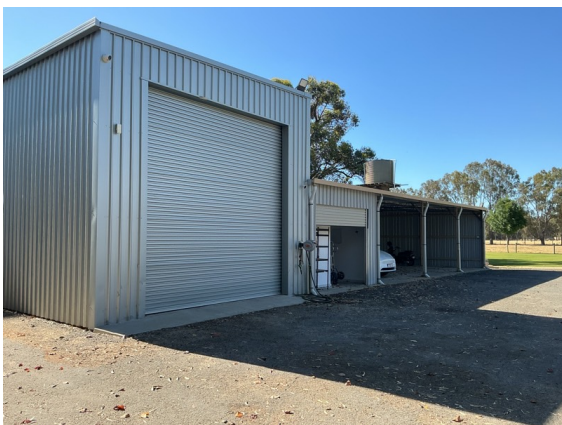
The inspector is not required to comment on individual minor defects and imperfections. If noted, it is expected that defects of this type would be rectified as part of normal ongoing property maintenance.

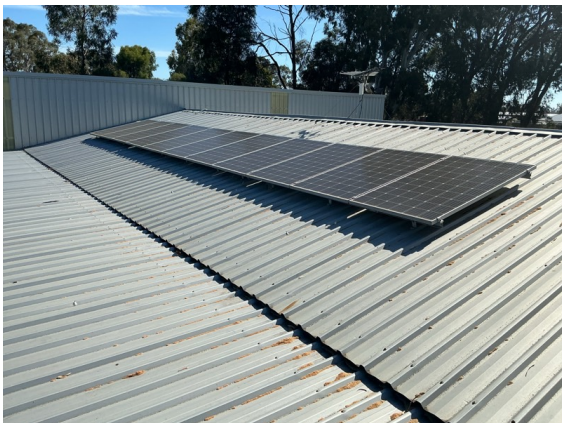
East elevation roof exterior

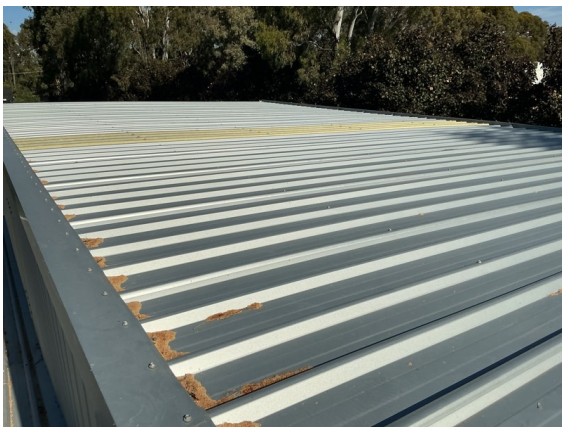
Minor deterioration noted to the fibreglass skylight sheets. Recommend maintenance/repairs.

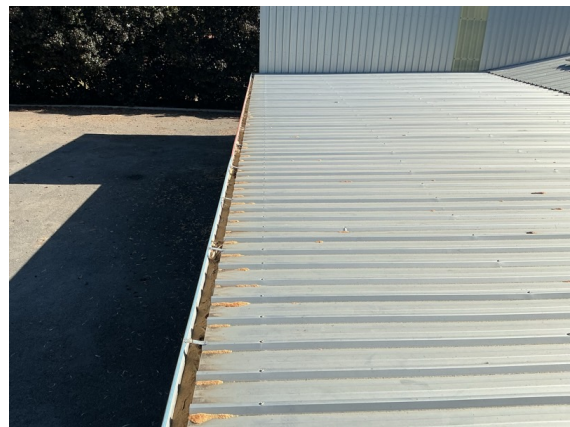
Debris in the gutters on various elevations. Recommend keeping the gutters and down pipes clear to allow adequate flow to the storm water system.

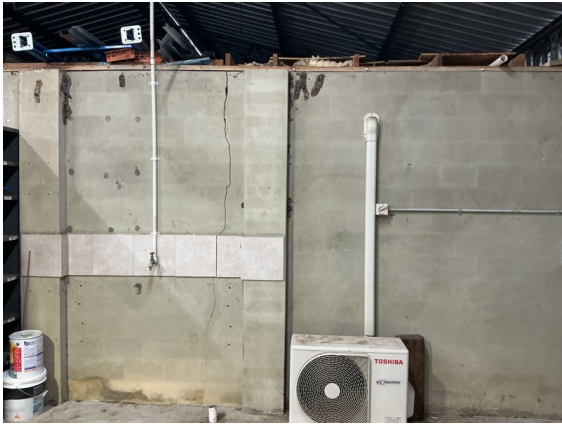
Southeast elevation - Vertical cracking observed to various areas of the shed living areas. Recommend repairs or seek further advice from a Structural Engineer.

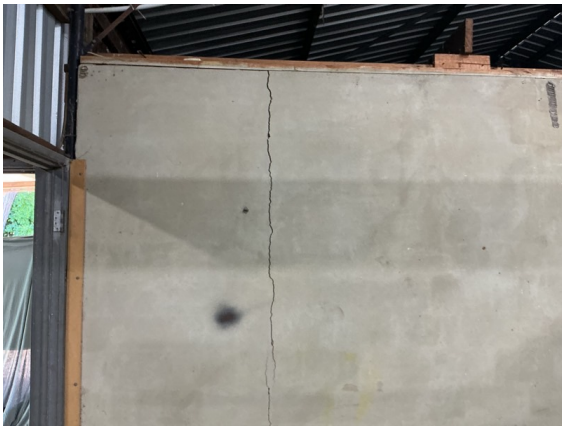
Southwest elevation - Vertical cracking observed to the shed living area.
